Disability Standing Committee

ACCESSIBLE BARRIER REPORT
Americans with Disabilities Act
and
2021 IBC with ICC A117.1-2017

Site Inspection conducted by
Stan Ross and Josh Lopez

Thank you for the opportunity to be of service to you by performing an accessibility evaluation for the Employee spaces of the New Mexico Workforce Connection located at 501 Mountain Road Albuquerque, New Mexico. The facility was inspected on 10/23/2023.

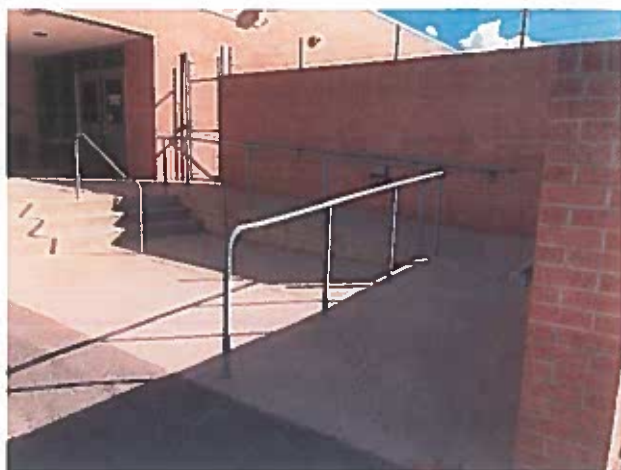
We observed several employee entrances. The first on the south end of the west side appears to be a break area and required steps down to the pavement without a ramp being present. I believe an 'exit' sign was in the interior space directing staff to a second entrance down a short corridor. At this second west side of the building exit there were steps as well as a ramp. This ramp is steeper than 1:12, and thus is not accessible.

This ramp occurs in the employe parking area and exceeds the maximum slope of 1:12. Signage in the employee break area adjacent through a short corridor with directional exit signage to this exit door, it serves as an accessible route exit and should be brought into ADA compliance. The gate at the top of the ramp with barbed wire topping may provide an alternative ramp area, which might be connected with the adjacent break room providing accessible exiting from both spaces as a possible solution.

Ramp exceeds 1:12 slope.

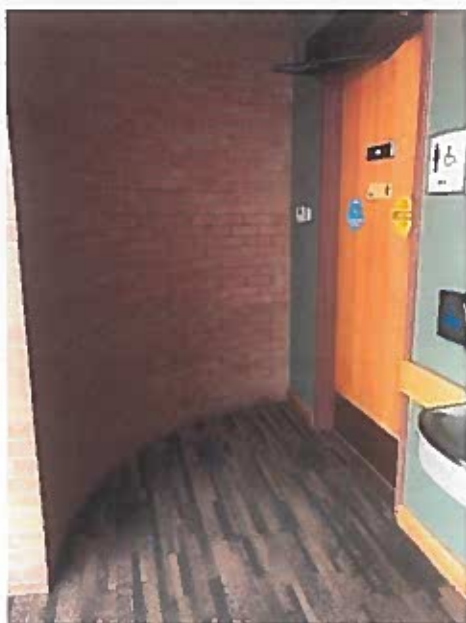
The POT within the facility meets the proper width requirements to be accessible with the (potential) exception of the bathrooms. The entry bathrooms are shielded from view by a curved wall outside the entry doors.

Alcove entry into bathroom

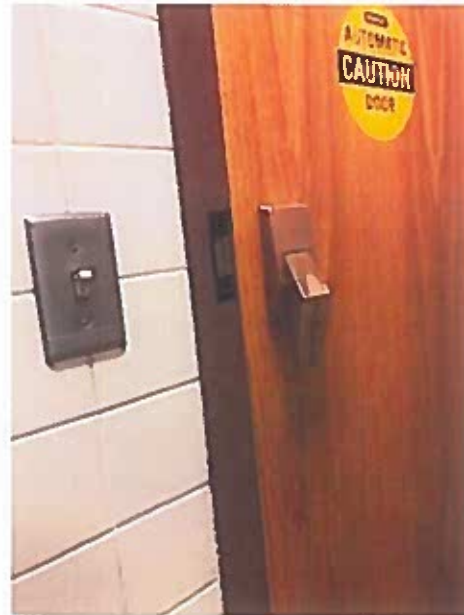
Exit from bathroom interior.

Note that the perpendicular measurement at the interior approach from the hinge side of the face of the door calls for a 48” minimum distance to the face of the wall, and a 54” minimum if the door is equipped with a closer, which this door is. However, if the door is equipped with a power assisted device as this one is, then the door approach requirements are acceptable. If the power assist is not operational, then the approach dimensions are noncompliant with the ADA Standards. GCD recommends the bathroom doors be checked for power assisted operation daily, and if power assist is not operational, service should be attended to as soon as possible. Also, for consideration note the flat lever hardware to open the door. *In my opinion*, for optimal operation, the hardware is upside down. Imagine yourself in a wheelchair opening the door from the inside. This particular lever handle raises up as you lift and pull. Sitting in the wheelchair, as you lift up your hand and raise your arm your strength and power weaken as you raise your hand. If the lever is reversed and the user in a wheelchair is pulling the handle, as it opens you are pulling down and bringing your hand in a direction of increasing strength as it gets closer to your body mass. We see these flat lever type door pulls frequently installed in both directions.
