Disability Standing Committee

ACCESSIBLE BARRIER REPORT
Americans with Disabilities Act
and
2021 IBC with ICC A117.1-2017

Site Inspection conducted by
Stan Ross and Josh Lopez

Thank you for the opportunity to be of service to you by performing an accessibility evaluation for the Employee spaces of the New Mexico Workforce Connection located at 501 Mountain Road Albuquerque, New Mexico. The facility was inspected on 10/23/2023.

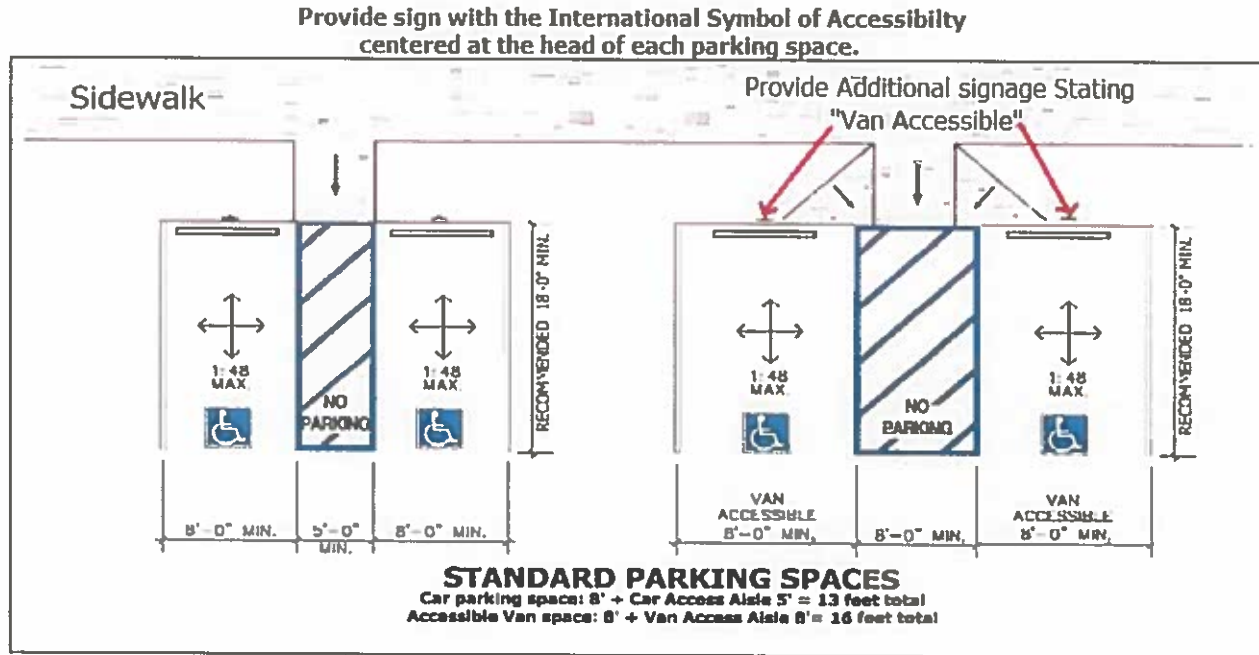
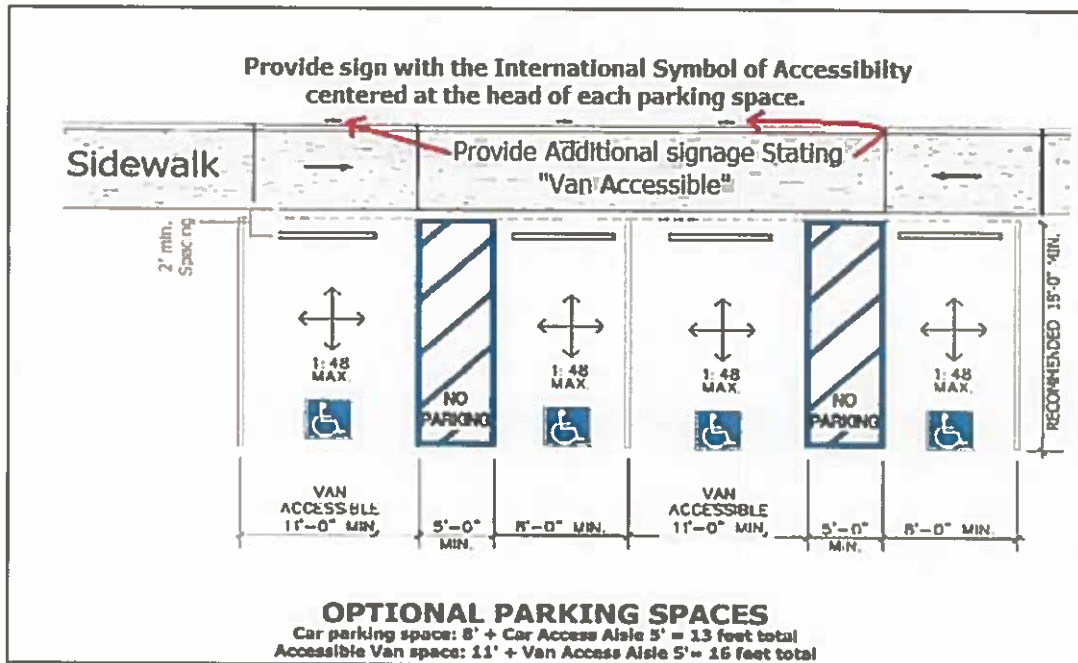
The minimum required number of accessible parking spaces is based on the total number of parking spaces provided (1-25=1 space, 26-35=2 spaces, or 36-50=3 spaces, of which 1 is required to be Van Accessible). The accessible spaces observed exceed the maximum 1:48 slope in all directions (requiring

regrading or build-up of surface to 2.08% maximum slope), and do not provide the required signage at all stalls or directional signage to the accessible path of travel. Please ensure that the dimensions for the accessible parking spaces with adjacent access aisle are similar to one of the following options shown below:

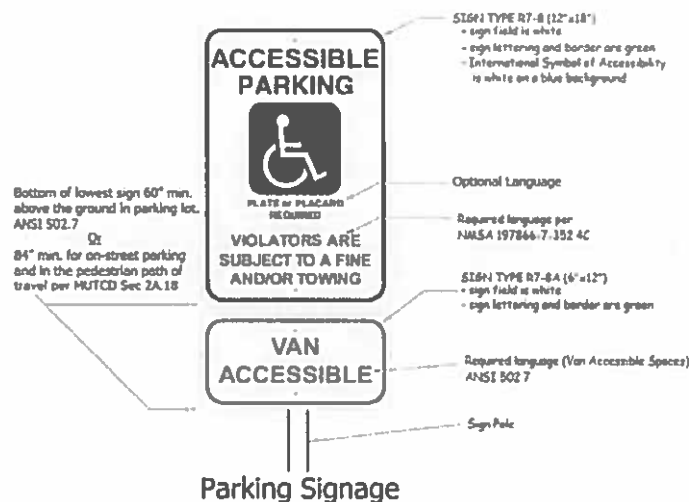
Two of the five identified accessible parking stalls currently located at 301 W. DeVargas do provide the proper code required signage, centered at the head of each parking space. The remaining three stalls should provide signage with the following items to ensure compliance.

- *GCD recommends signs to be white background with a green border and legend (MUTCD sign # R7-8 and R7-8A).*
- Sign must include the language “Violators are subject to a fine and/or towing” (66-7-352.4C NMSA 1978, Effective 7-01-2010). See sign sample below.
- In parking lots the bottom of the sign is required to be 60” minimum above the ground or parking surface. (ANSI 502.7).

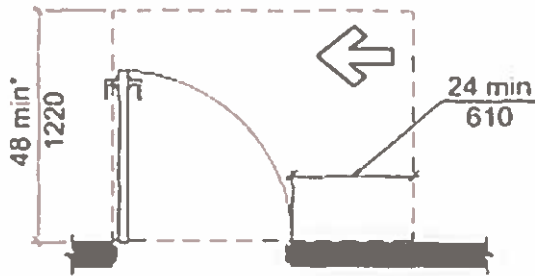
(f) Latch Approach, Pull Side

Note that the perpendicular measurement from the hinge side of the face of the door calls for a 42” minimum distance to the face of the wall, and a 48” minimum if the door is equipped with a closer, which this door is. The measurement from the center of the door to the wall is 49”.

Perpendicular to the hinge the clearance dimension is insufficient. However, if the door is equipped with a power assisted device as this one is, then the door approach requirements are acceptable. If the power assist is not operational, then the approach dimensions are noncompliant with the ADA Standards of 5 pounds of pressure to open the (interior) door. GCD recommends the bathroom doors be checked for power assisted operation daily, and if power assist is not operational, service should be attended to as soon as possible.
